Completion Report

UIS-226/20

1-24 Belmont Court

Hertfordshire

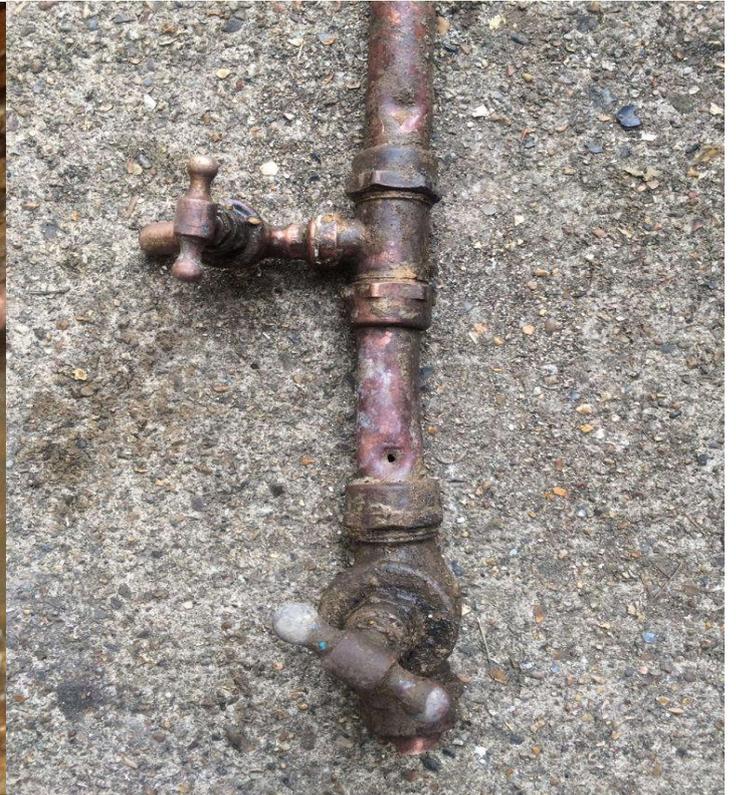
Appendix 4

Description of works undertaken	<p>We attended site regarding the leak affecting the property.</p> <p>We CAT Scanned the proposed working area and set up a safe site.</p> <p>We excavated the external stop tap and exposed the pipe work. The leak was a 22mm stop tap (Appendix 4) the pipe work had a pin hole.</p> <p>We cut out the failed stop tap and copper pipe work, we installed a new 25mm MDPE inline stop valve</p> <p>We made new connections and tested our installation.</p> <p>We backfilled with as dug material and reinstated the concrete footpath</p> <p>We cleared site.</p>
Please take pictures of each working stage and any relevant additional information (i.e pre start damage etc.).	
Site drawing	
Site Left	
Fittings Used	
Hours Spent
